HERBICIDE ORANGE SITE CHARACTERIZATION STUDY EGLIN AFB

FINAL REPORT
APRIL 1984 - SEPTEMBER 1986

This report describes the procedures, results, and analysis of a soil sampling program performed at, and in the immediate vicinity of, the Hardstand 7 area of EAFB. In accordance with a previously approved sampling protocol, 276 samples of soil and concrete were collected from the hardstand area, which is about 130 feet in diameter, and includes a 10-foot-deep concrete pit also contaminated by HQ handling. In addition to the soil and concrete samples, over 75 laboratory analyses were performed and reported for a variety of quality assurance criteria.

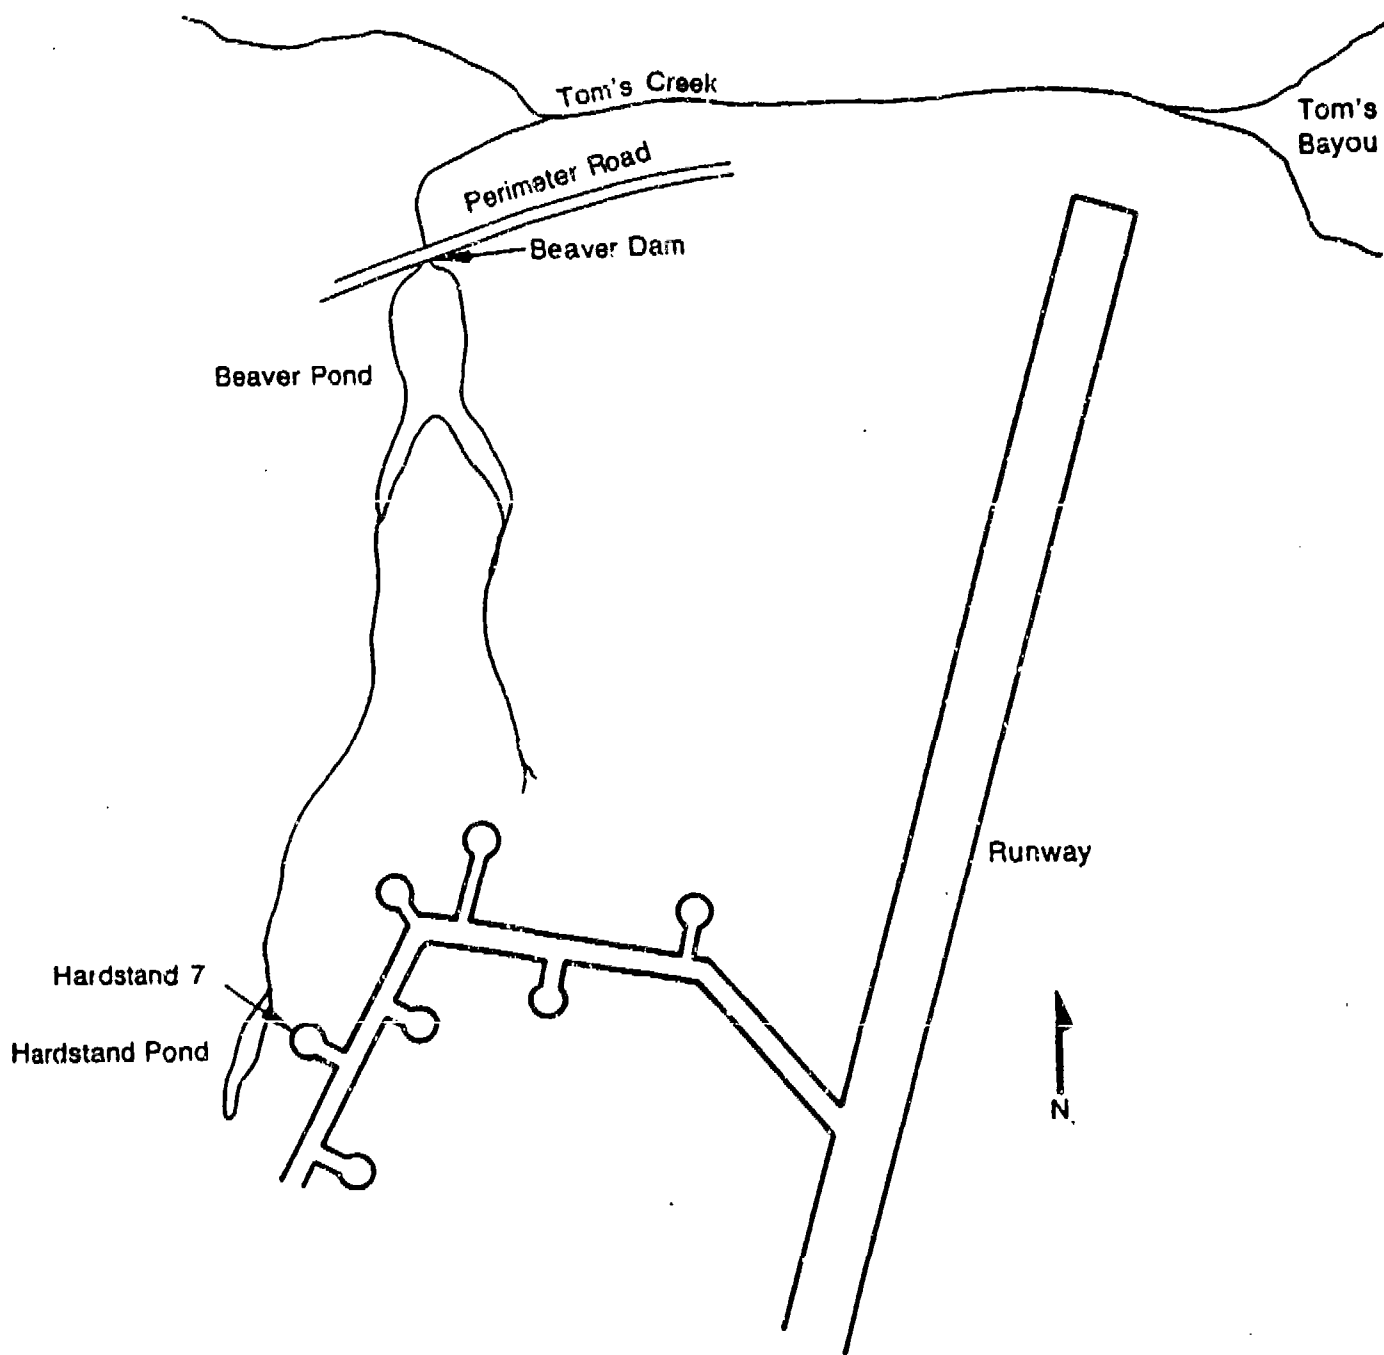
Figure 2. Location of Hardstand 7 and Surface Water Drainages.

Hardstand 7 is a concrete and asphalt aircraft parking area located west of the north-south runway on the main EAFB airdrome (Figure 2). It is connected to the runway by an asphalt taxiway to the east. The hardstand diameter, including concrete and asphalt, is about 130 feet. A 10-foot-deep concrete pit with a stairway leading to the bottom is located near the back of the hardstand opposite the apron leading to the taxiway (Figure 3). The pit was also contaminated by the handling of HO.

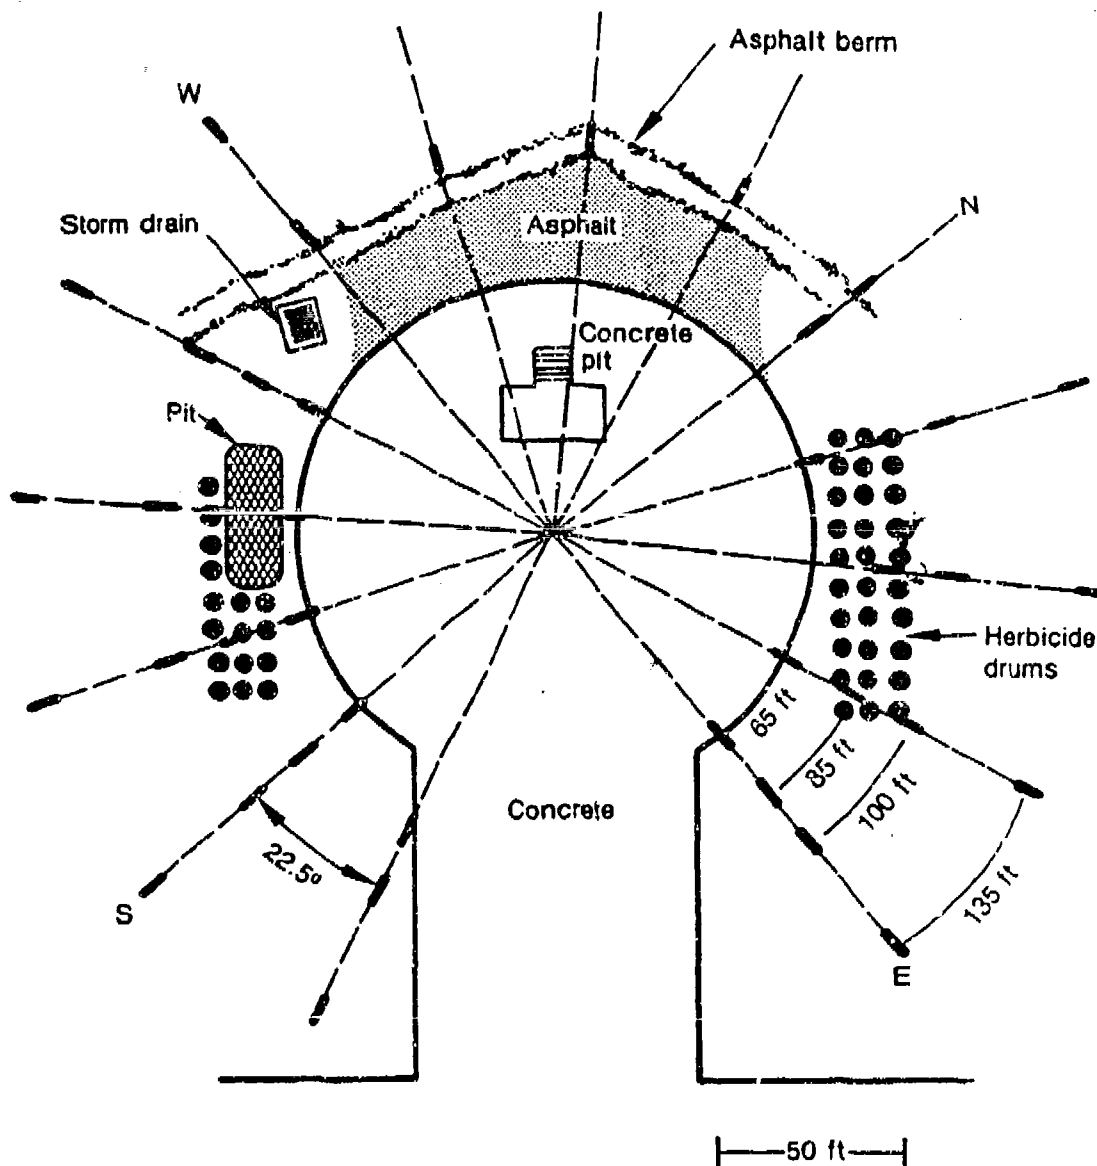
Figure 3. Hardstand 7 Herbicide Orange Storage Locations.

Contamination of the hardstand resulted from spills during handling, leaking drums, and purging of aircraft spray systems. A soil pit, dug on the southwest edge of the hardstand in 1969, collected spilled herbicide to prevent downslope runoff. After several months of use, this pit was filled in. Known storage locations on the hardstand are shown in Figure 3.

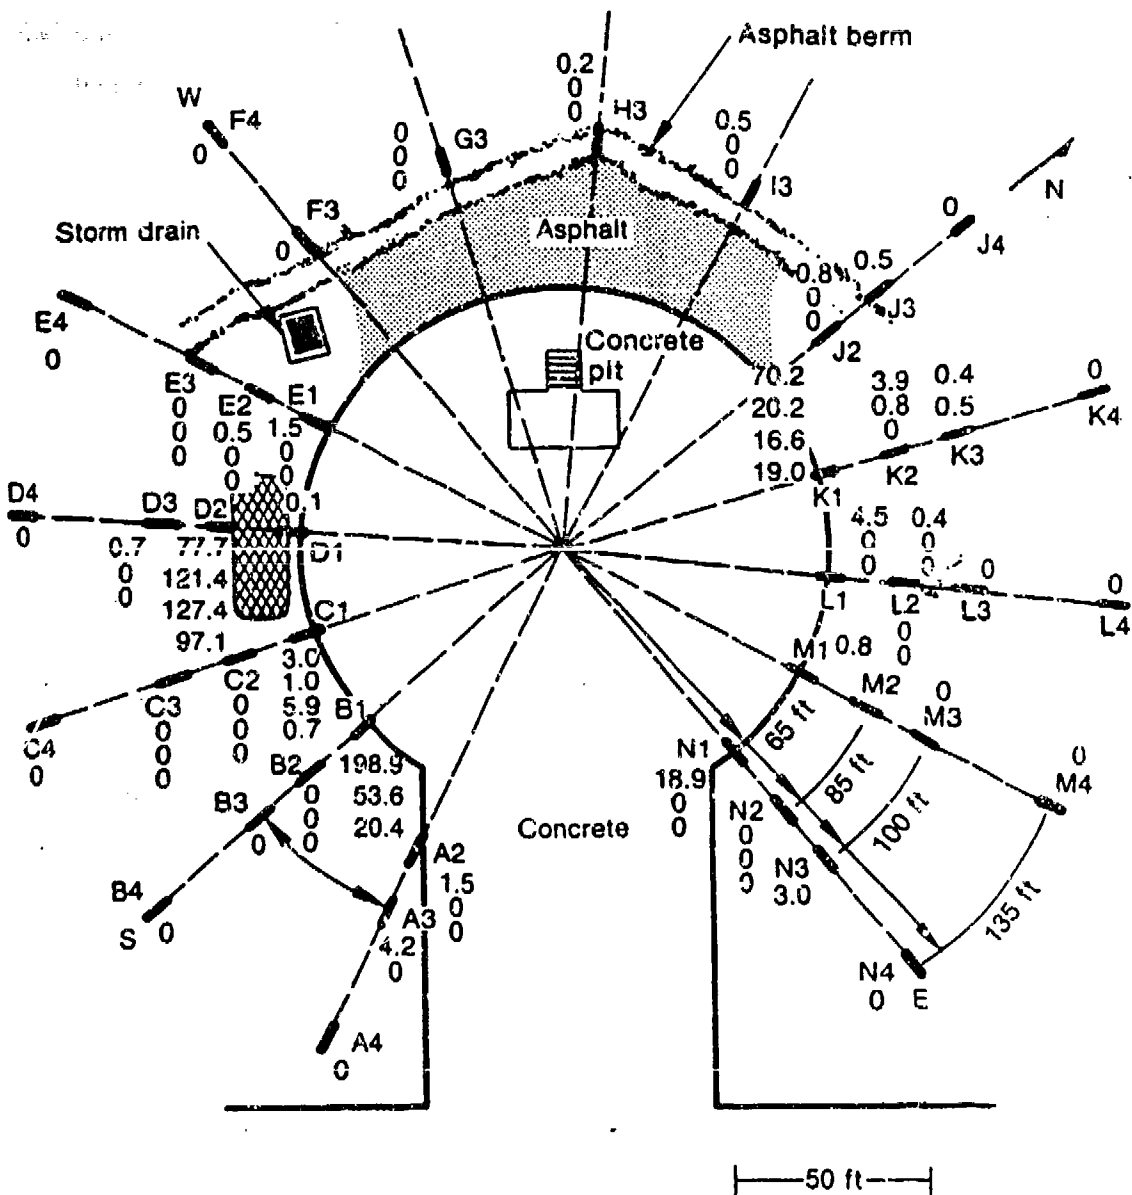
Figure 4. Concentrations (in ppb) of Dioxin Found in Soils Around Hardstand 7 (Reference 2).

Both soil and biological samples have been taken at Hardstand 7 and Hardstand Pond (Reference 2). Figure 4 shows the soil sampling sites around the hardstand. Samples were taken at depth intervals of 0 to 4 inches, 8 to 12 inches, 22 to 28 inches, and 37 to 43 inches. All depths were not sampled at all locations. The highest concentrations found were

198.9 ppb at the surface and 127.4 ppb at 22 to 28 inches. A previous sampling study showed 275 ppb in a 0- to 4-inch depth interval south of the concrete pit (Reference 1).

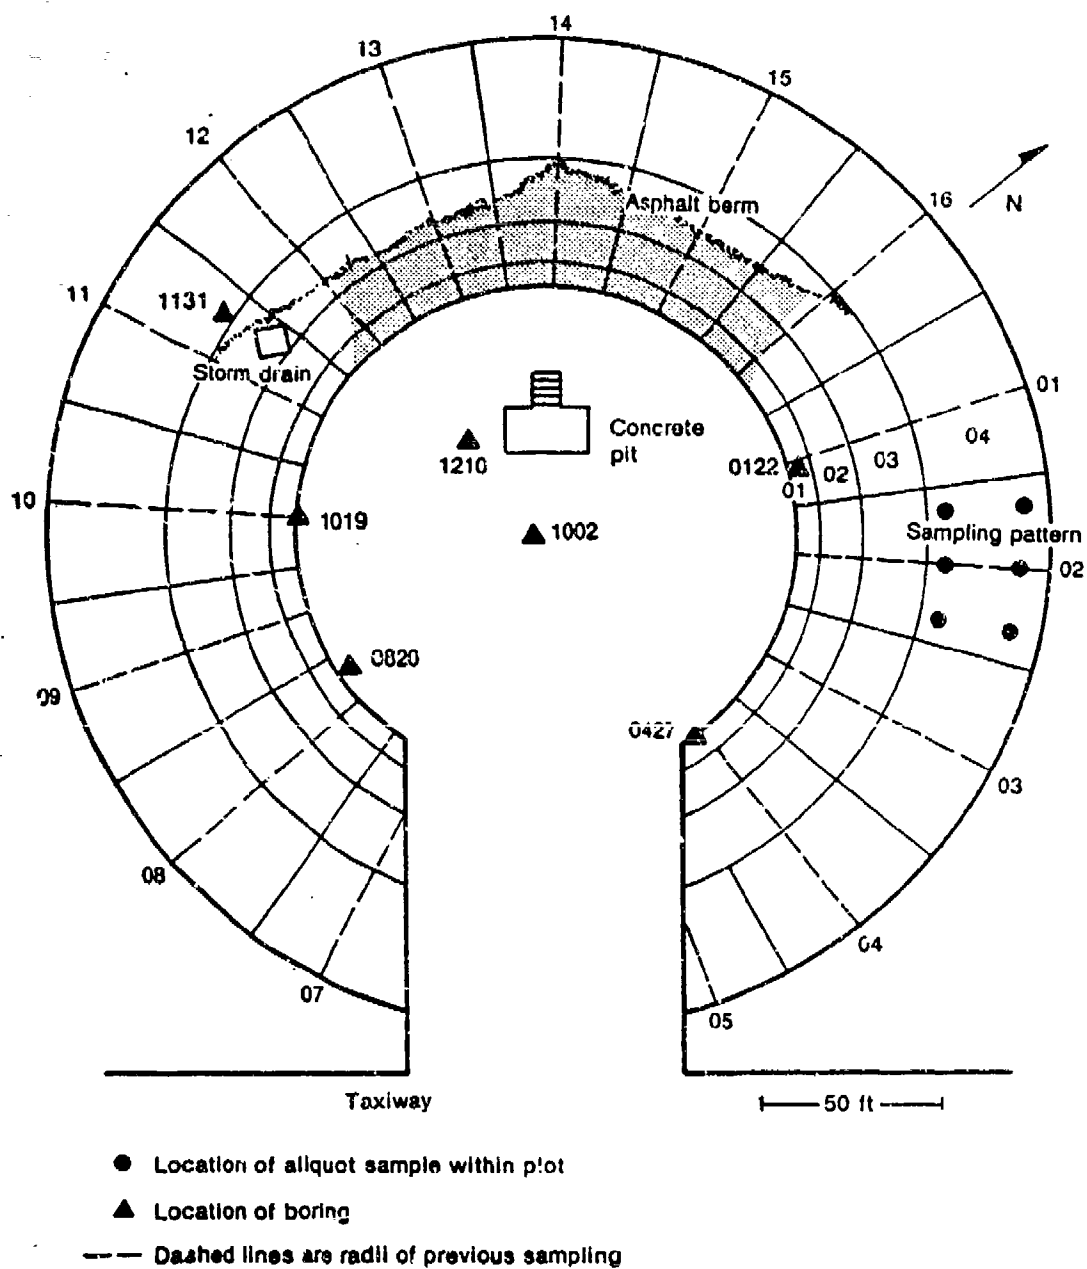
Figure 5. Locations of Surface Sampling Grid and Subsurface Drilling Locations.

To determine levels of surface soil contamination around the hardstand, a radial sampling grid was established (Figure 5). This grid was designed so that the radial lines established in the previous sampling (Reference 1) intersected the center of each sampling plot. This design allows comparison with historical sampling and provides additional coverage of the soils around the hardstand. Because surface contamination is primarily a result of surface runoff, it was assumed that contamination of soils decreases away from the hardstand. Sampling plots were designed to increase in surface area with distance from the hardstand. Plots closest to the hardstand were kept small to minimize the amount of decontamination needed, should remedial action be required. Centers of the four plots on each radius were at 65, 73.5, 87, and 111 feet from the center of the hardstand. Radii were designated by numbers 01 through 16, beginning from the north. Sample plots were numbered 1 through 4 outward on each radius.

A six-aliquot sample was collected from each plot, as shown in Figure 5. Aliquots were taken from 0 to 3 inches deep, using a new tablespoon for each plot. Soils were sieved through a 10-mesh screen into a disposable aluminum pan where they were thoroughly mixed before transfer into new 8-ounce wide-mouth glass sample jars. Jars were filled two-thirds full and capped with aluminum foil-lined caps. In locations where the sample aliquot was on asphalt, the asphalt was removed with an air hammer, and soil was taken from beneath the asphalt layer. All holes dug in the asphalt were patched. Replicate samples for quality assurance (QA) were taken from two plots. These involved taking five complete six-aliquot samples from each plot. Four additional samples were taken by shifting the sample grid in four directions. All samples were analyzed for dioxin to a target detection limit of 0.01 ppb.

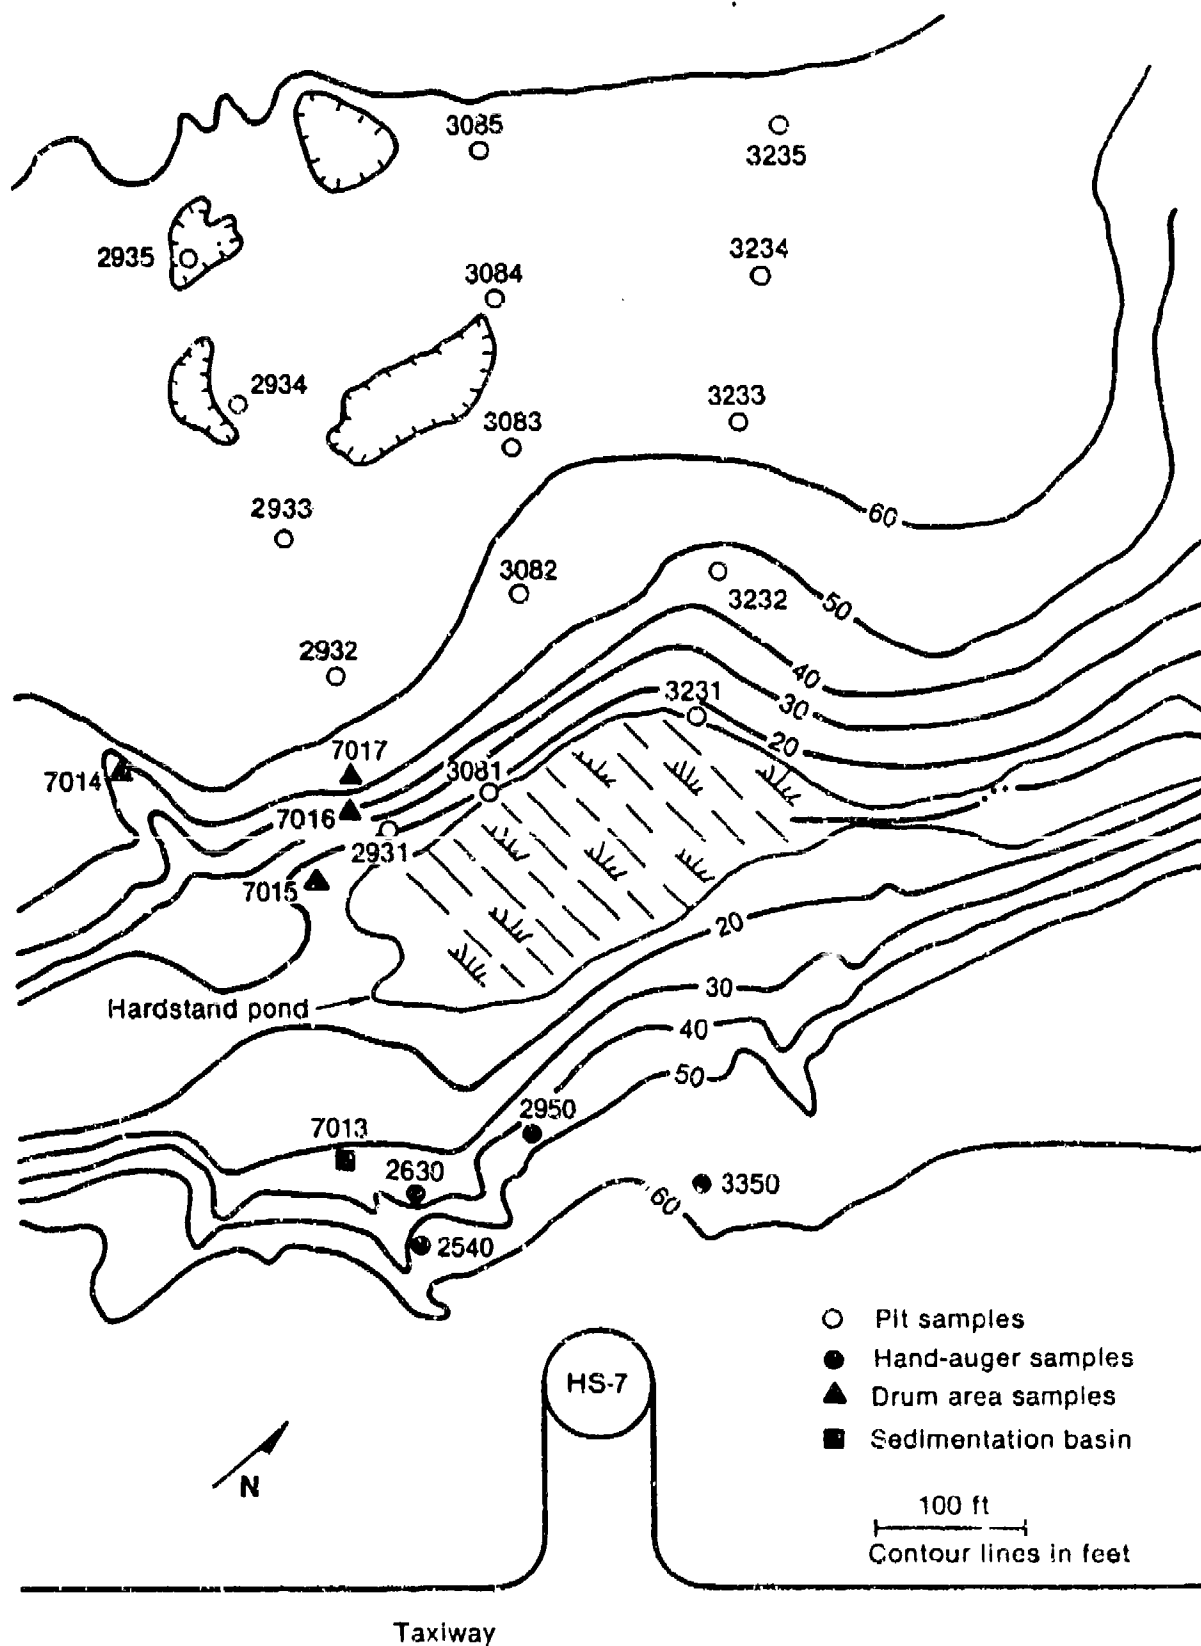
Figure 6. Location of Samples Taken in Hardstand Pond Area.

Near-surface samples were collected from 15 pits located in three radial lines trending up the back slope away from the Hardstand Pond (Figure 6). These samples were not intended to give complete coverage of

the slope, but to provide representative soil samples that may have been contaminated by prop wash and prevailing winds. Radial lines were set at 293, 308, and 323 degrees azimuth from north, measured from the middle of Hardstand 7. Five pits were dug along each line, beginning near the edge of the pond, then every 100 feet along the line to 400 feet away from the pond. Sample location numbers are indicated by the radius, and numbers 1 through 5, starting with the pit nearest the pond. Each pit was dug, using a pick and shovel, to a total depth of 3 feet. A face on the pit wall was scraped clean before sampling. Samples were collected, using a new spoon for the intervals: surface to 1 foot, 1 to 2 feet, and 2 to 3 feet. Samples were collected, starting at the bottom of the pit, to minimize cross-contamination from soil falling into the pit from higher intervals. All samples were sieved through 10-mesh screen and spooned into jars using procedures described previously. Near-surface samples were analyzed for dioxin to a target detection limit of 0.1 ppb.

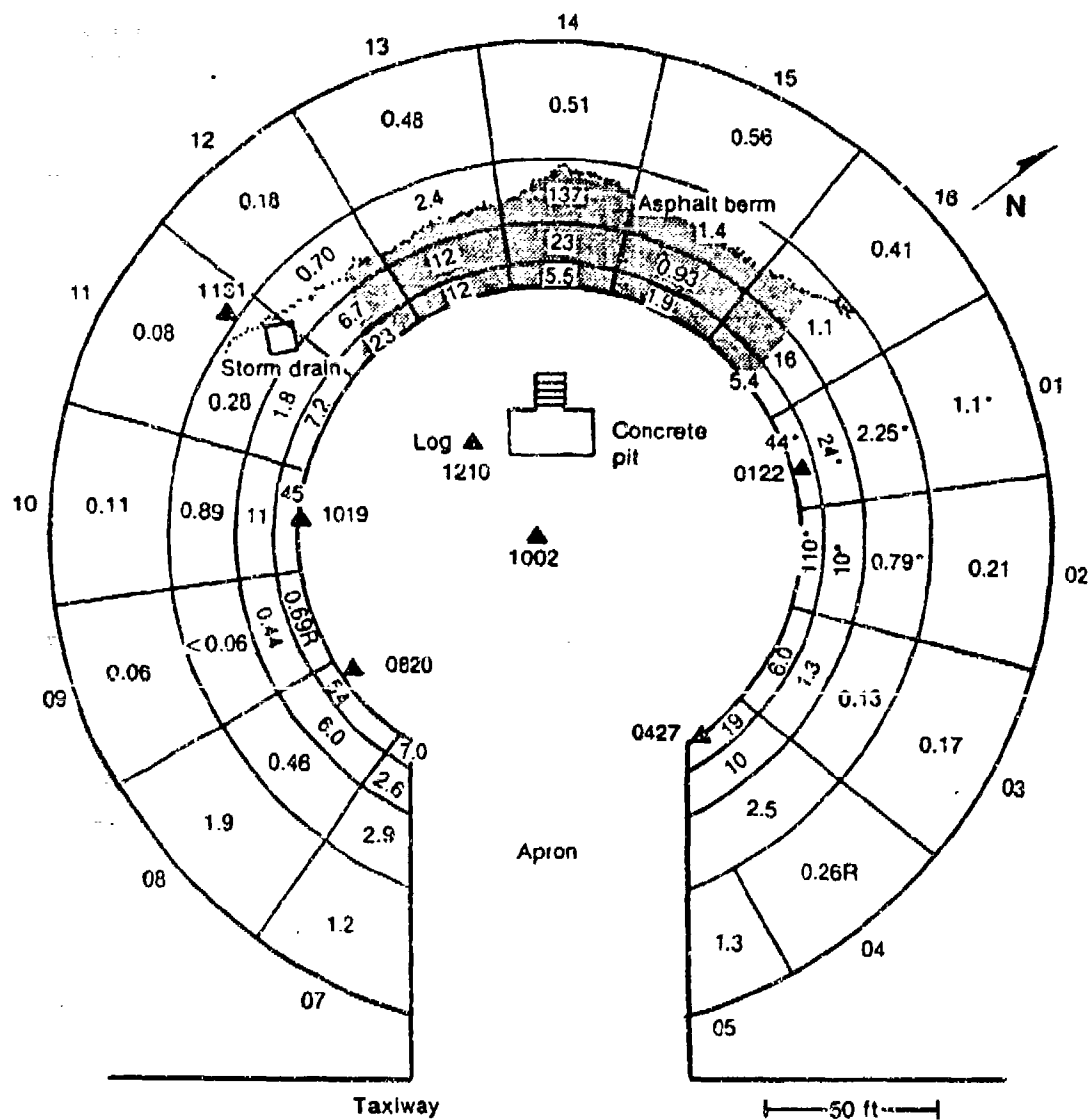
Figure 8. TCDD Concentration of Composited Surface Samples and Replicated Locations.

The highest value (137 ppb) is from a plot located to the northwest of the hardstand at an apparent low point where runoff from the hardstand would tend to collect. Other areas showing elevated concentrations in surface soils include the area of the former pit immediately southwest of the hardstand. Surface TCDD concentrations in this area ranged to 45 ppb. Another area of elevated TCDD concentration (110 ppb) was found to border the hardstand on the northeast. TCDD concentrations in plots bordering the apron leading to the hardstand ranged from 1.2 to 10 ppb.

In general, TCDD concentrations in surface soils decrease rapidly with distance from the hardstand. Values for the innermost ring of plots averaged over 25 ppb, while those for the outermost ring averaged 0.57 ppb

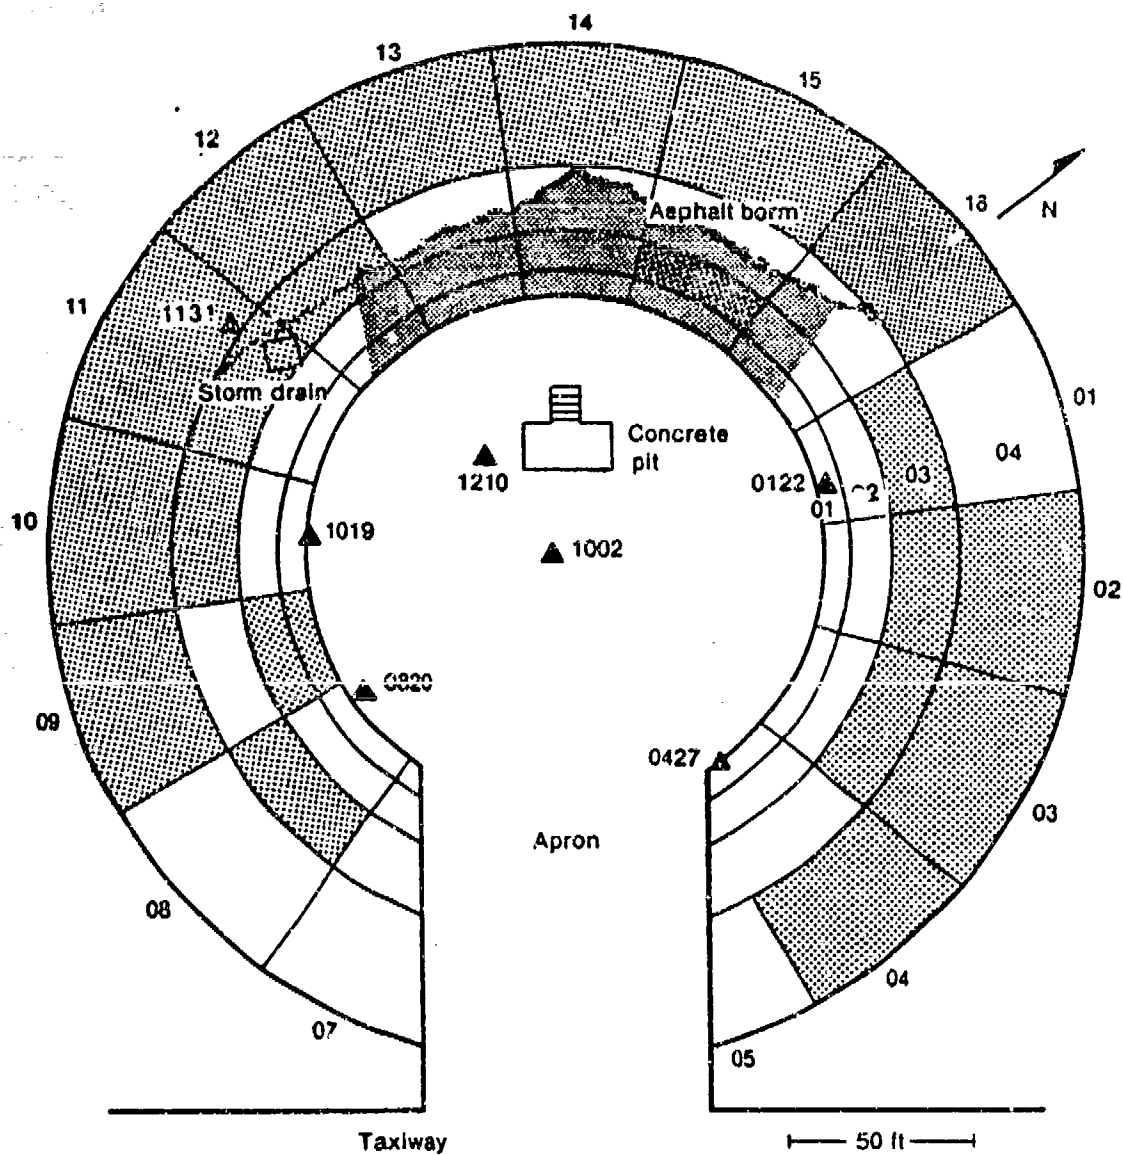
Figure 9. TCDD Concentrations of Composited Surface Samples, > Detection or Reporting Limit through 1.0 ppb.

Fifty-seven surface plots surrounding Hardstand 7 (Figure 5) were sampled and analyzed to determine TCDD concentrations in the top 3 inches of soil. Surface plot TCDD values, using the arithmetic means for the two replicated plots, range from none detectable (<0.06 ppb) to a high of 137 ppb. Figure 8 presents the values of all surface plot composite samples. Figures 9 through 14 present the surface TCDD concentrations in the following ranges: detection or reporting limit through 1.0 ppb, greater than 1.0 ppb through 10 ppb, greater than 10 ppb, greater than 25 ppb greater than 50 ppb, and greater than 100 ppb. Figure 15 summarizes the number of plots in each concentration range and shows the frequency distribution for those ranges. As shown in Figure 15, over 75 percent of all test plots had composited sample concentrations at less than 10 ppb. Over 35 percent had concentrations less than 1 ppb. TCDD was not detected in one plot.

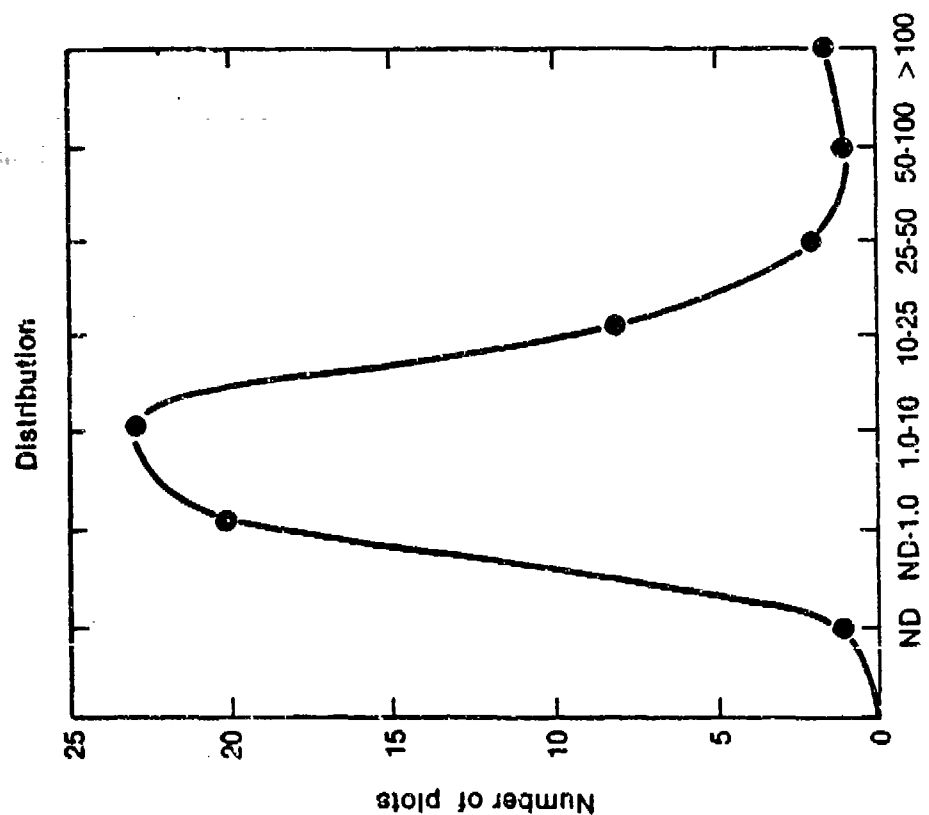
Figure 15. Frequency Distribution of Composited Surface Soil Plots.

ND—none detected

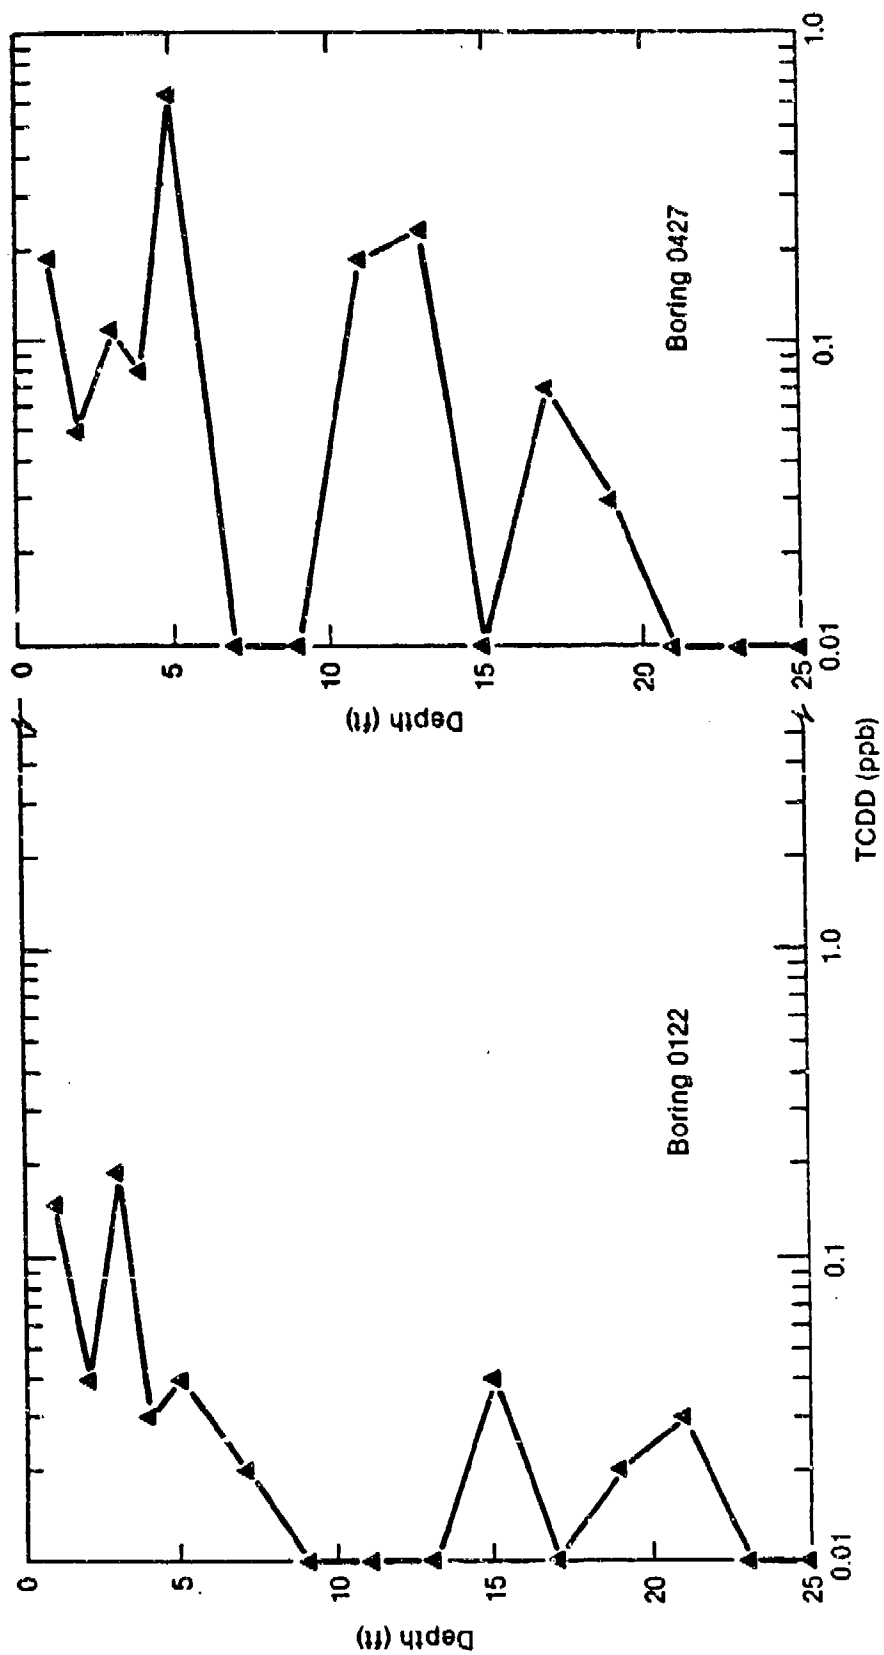
Figure 16. TCDD Concentrations vs. Depth, Borings 0122 and 0427.

TCDD concentrations in boring 0427 ranged from less than 0.01 ppb to 0.63 ppb. The plot of TCDD concentrations vs. depth in Figure 16 shows generally decreasing concentrations with increasing depth. TCDD concentrations were below 0.1 ppb at depths greater than 15 feet. Boring 0427 was located at the east edge of the hardstand in an apparent water drainage path. The surface soil composite near the location of boring 0427 had a TCDD concentration of 19 ppb.

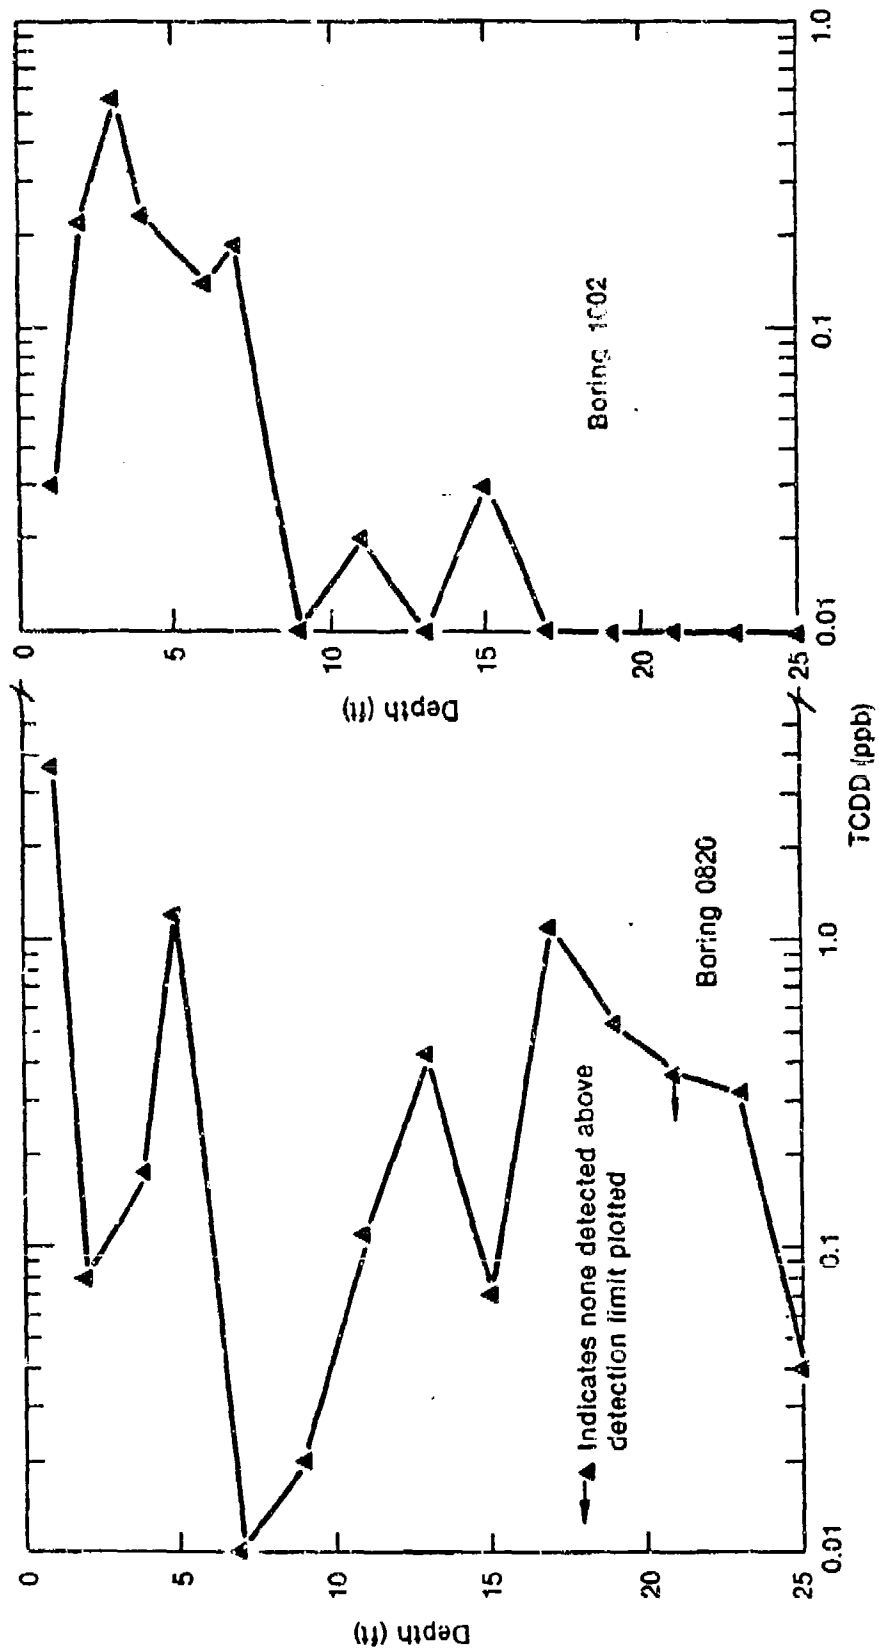
Figure 17. TCDD Concentrations vs. Depth, Borings 0820 and 1002.

TCDD concentrations at boring 0820 ranged from less than 0.01 ppb to 3.6 ppb. Figure 17 shows a plot of concentration vs. depth. TCDD concentrations above 1 ppb were found at depths up to 17 feet. The general trend of decreasing TCDD concentration with increasing depth is less apparent from the plot in Figure 17. Boring 0820 was located at the south edge of the hardstand where high levels of TCDD were found from previous surface sampling studies. The surface composite sample near boring 0820 had a TCDD concentration of 54 ppb.

Boring 1002 was located on a large concrete seam near the center of the hardstand. This location was selected to determine if significant transport of TCDD had occurred through the concrete seams in this area of the hardstand. TCDD concentrations ranged from less than 0.01 ppb to 0.56 ppb. The profile of TCDD concentration vs. depth shown in Figure 17 indicates levels well below 0.1 ppb at depths greater than 8 feet. A strong trend of decreasing concentration with depth is evident.

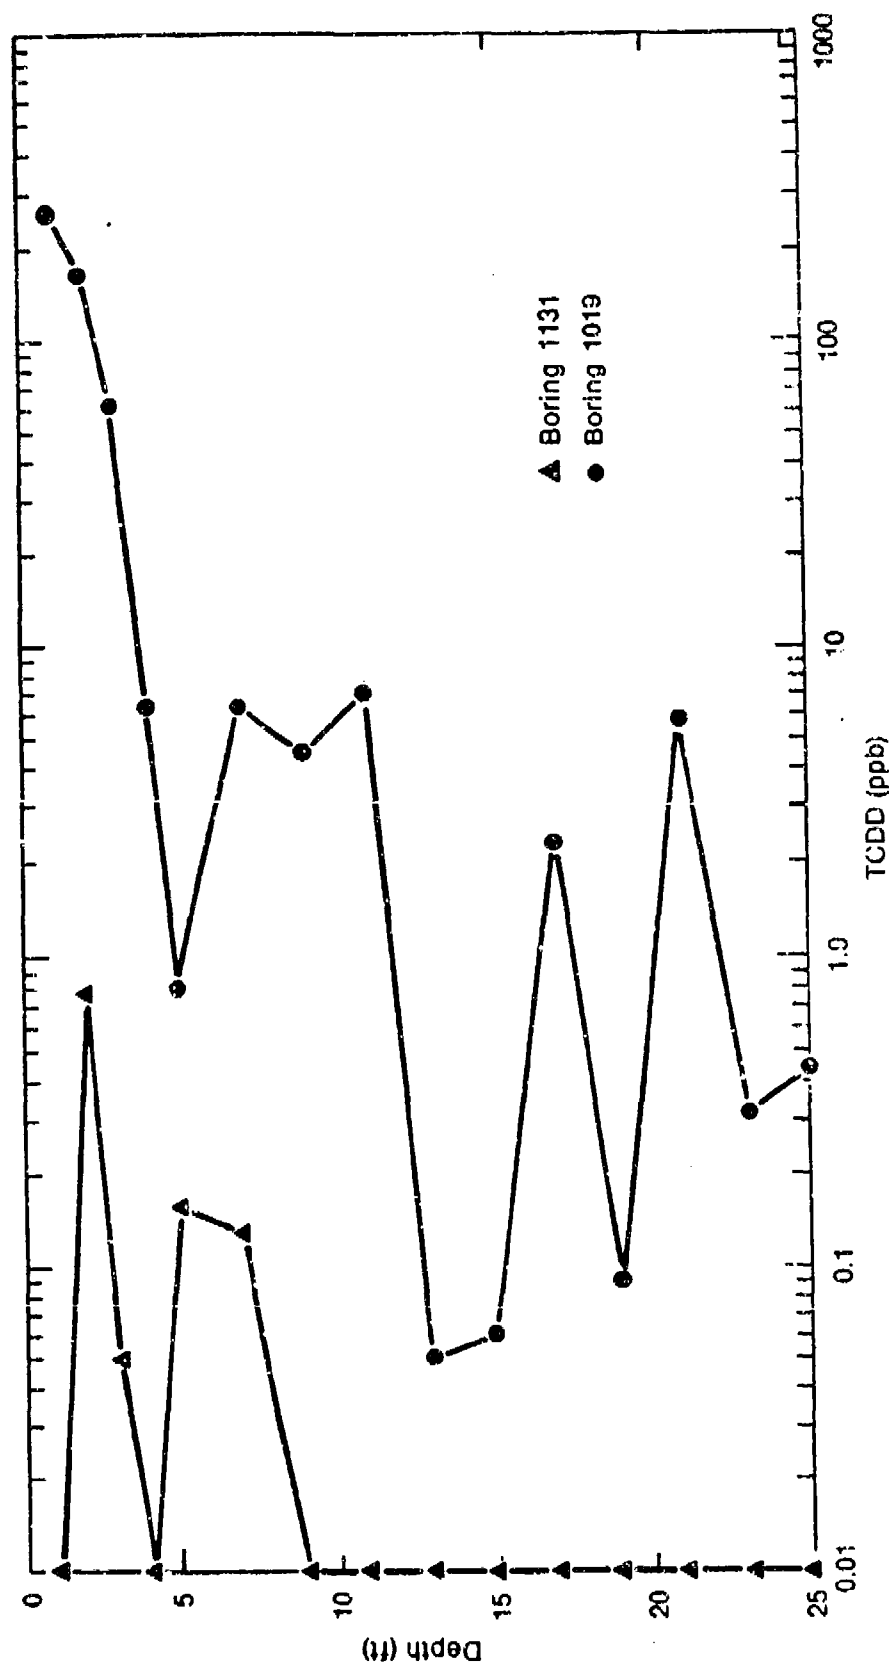
Figure 18. TCDD Concentrations vs. Depth, Borings 1019 and 1131.

Boring 1019 was located immediately southwest of the hardstand near the filled pit site described in Section I. TCDD concentrations ranged from 0.05 ppb at a depth of 13 feet to 263 ppb at a depth of 1 foot. The plot of TCDD concentration vs. depth (Figure 18) shows a general decrease in concentration with depth; however, values well above 1 ppb were found at depths up to 21 feet. Dark reddish-brown staining was observed on soils for the total depth of the boring; however, it became lighter and spotty below 6 feet. The data indicate that the area in the vicinity of the former pit has been significantly impacted by spills and runoff of TCDD to at least 21 feet. The composited surface sample for the plot near boring 1019 had a TCDD concentration of 45 ppb.

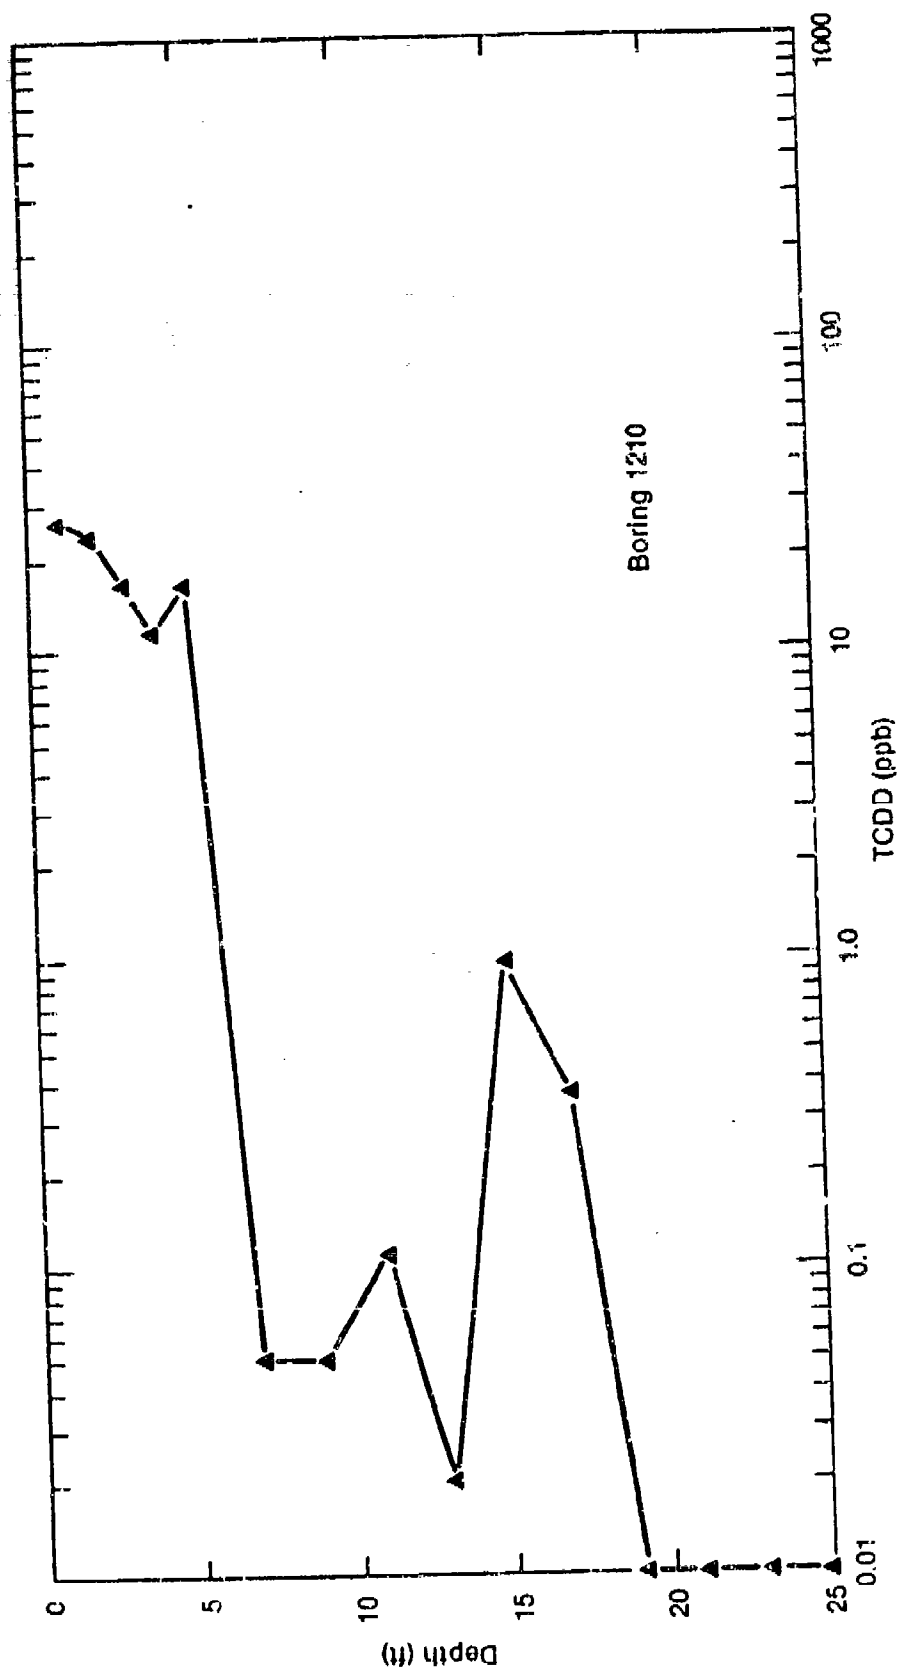
Figure 19. TCDD Concentrations vs. Depth, Boring 1210.

Boring 1210 was located near a previously drilled boring, which had significant TCDD concentrations at 9 feet. This location has asphalt overlapping cracked concrete. TCDD concentrations ranged from less than 0.01 ppb to 26 ppb at a depth of 1 foot. The plot of TCDD concentrations vs. depth is shown in Figure 19. The trend of decreasing concentration with increasing depth is clearly evident. Concentrations drop well below 1 ppb at depths greater than 6 feet; however, at about 15 feet, TCDD concentrations again rise to the one ppb level. This increase in concentrations between 14 and 20 feet may be the result of lateral transport from the area of the former pit.

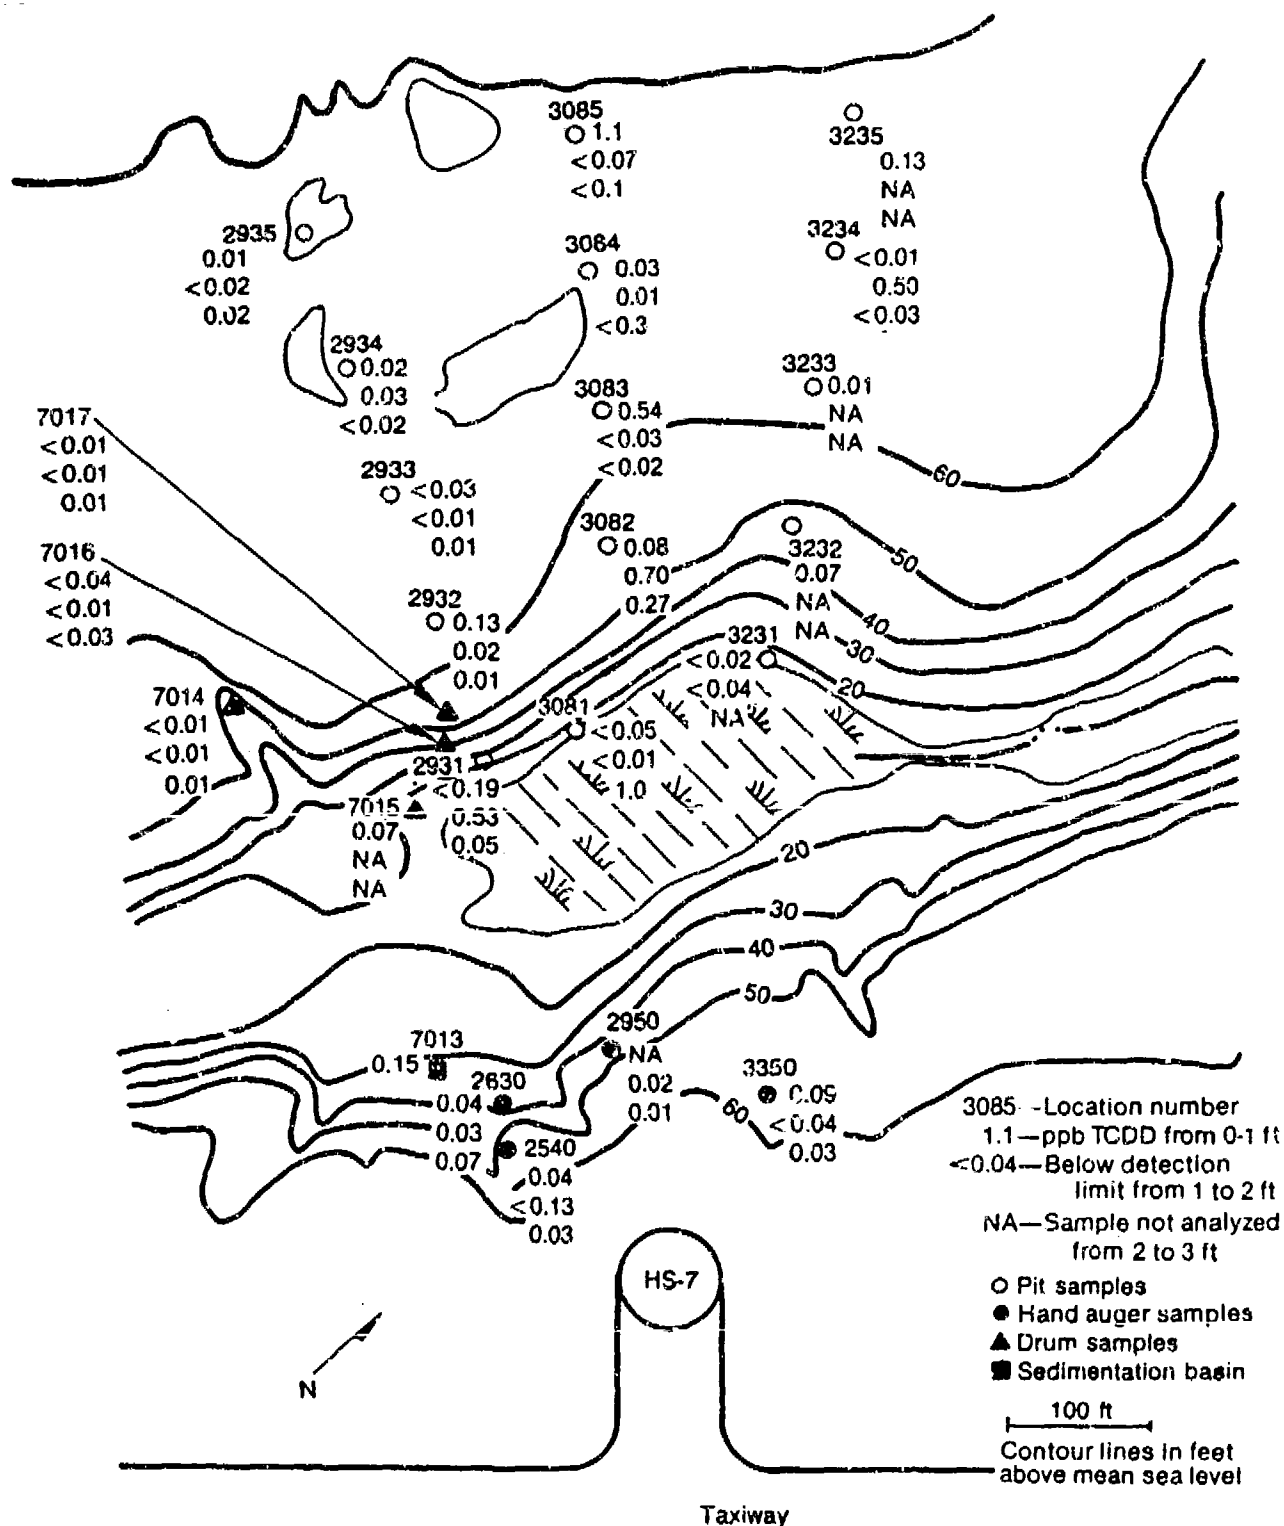
Figure 20. TCDD Concentrations at 1-, 2-, and 3-foot Depths Northwest of Hardstand 7.

(thickness) of fill material to stabilize the slope, thus, minimizing erosion. The location of the hand-auger holes are shown in Figure 20. Hole depths ranged from 13 to 17 feet, with sampling intervals identical to the subsurface drilling program at the hardstand.

The analysis of soil samples obtained from the hand-auger holes resulted in TCDD concentrations ranging from less than a detection limit of 0.01 ppb to 2.6 ppb. Only one sample exceeded 1.0 ppb. That result (2.6 ppb) was obtained from a sample at 9 feet in boring 3350. All remaining results were well below 1 ppb. The next highest concentration was 0.16 ppb. The arithmetic mean for all samples was 0.11 ppb. Plots of TCDD concentration vs. depth for the hand-auger borings are shown in Figure 21. Actual values are listed in Appendix A. The results indicate that significant contamination of subsurface soils in the area of the hand-auger borings has not occurred.
